B&W WELDING AND CONSTRUCTION
III. Site Investigation

B&W WELDING AND CONSTRUCTION
SITE INVESTIGATION

August 31, 1987

Re: Site Inspection of B & W Welding and Construction
JN 117203
TWC 14-70020

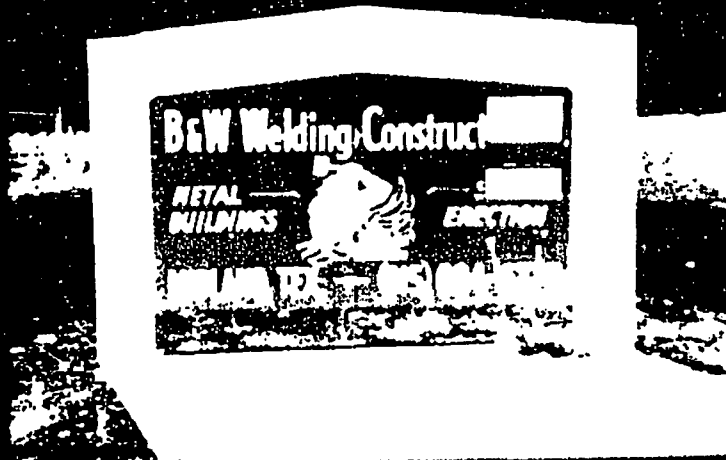
Photo #1 (23)

B & W Welding and Construction
Main entrance on west side.

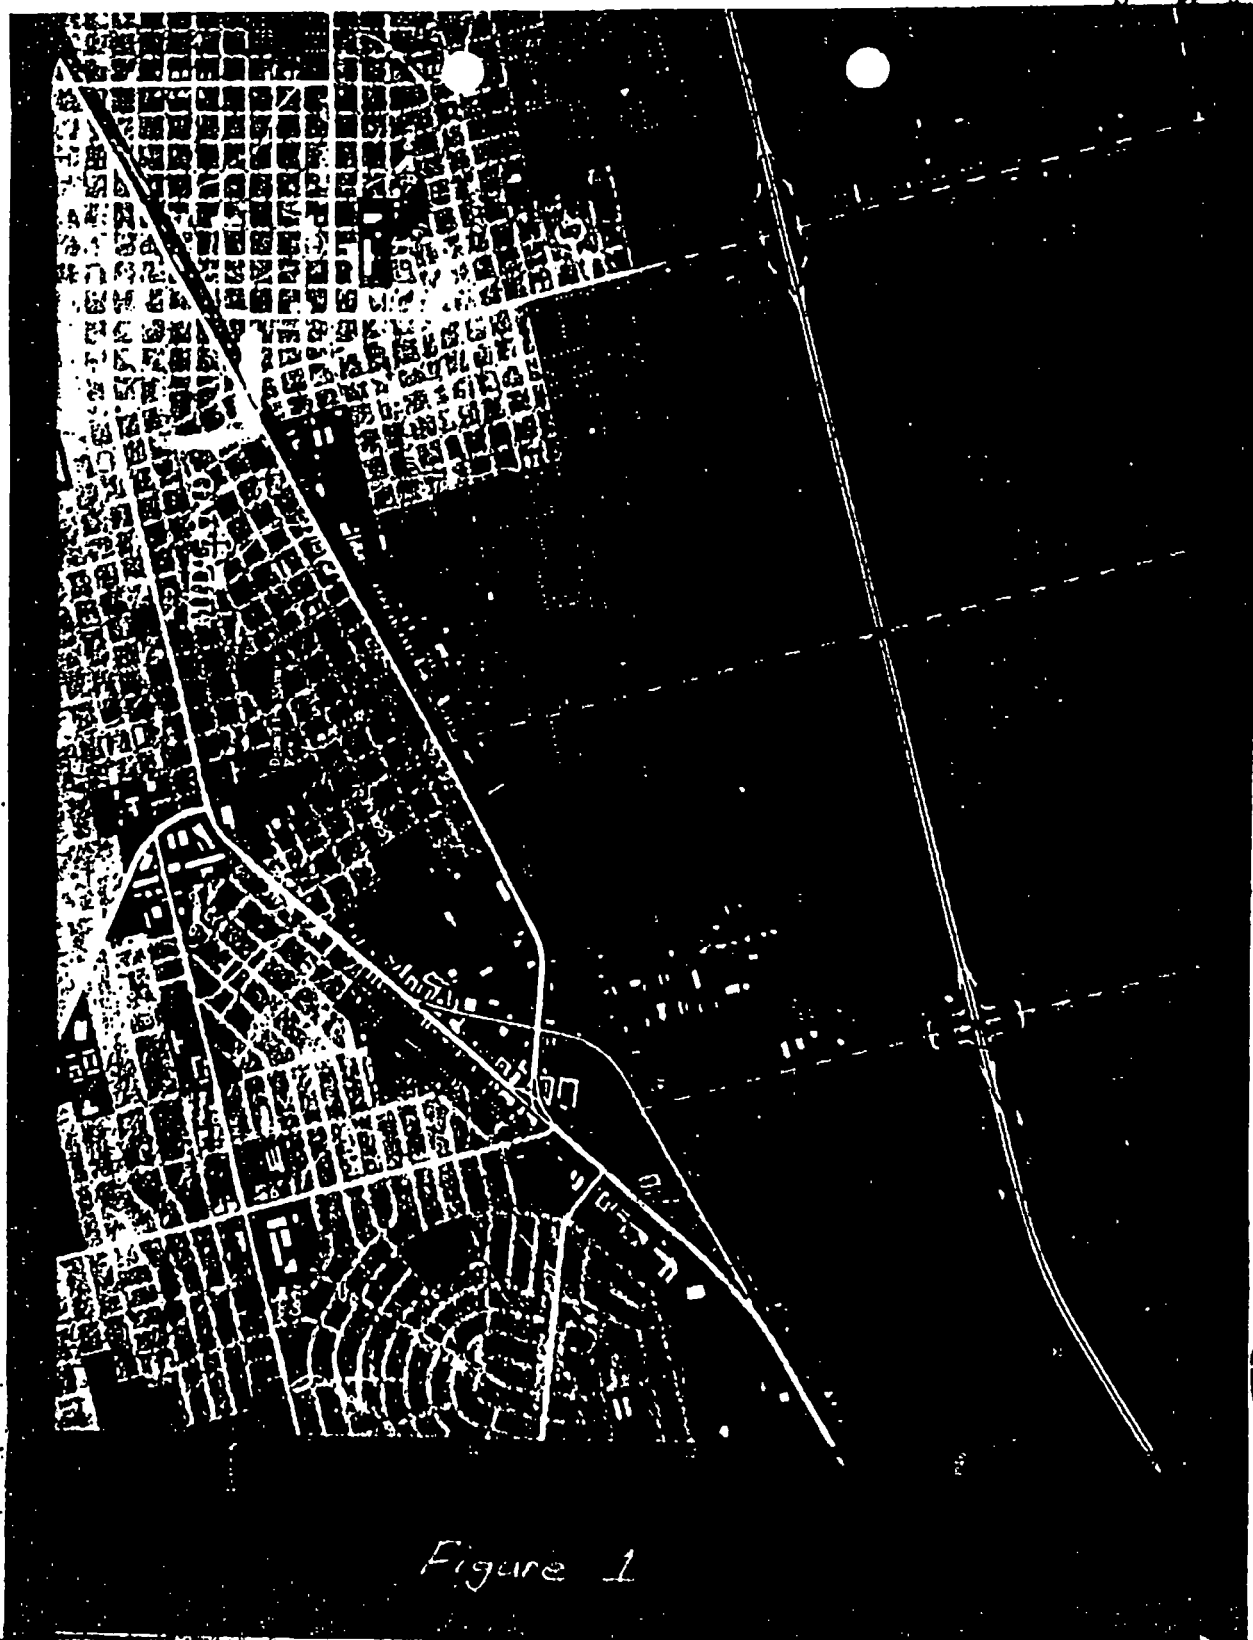
As shown in Figure 1, the contaminated well is on the edge of an industrial complex. Water depths and samples were taken from these water wells from an area to the west, around the north to the northeast. One well to the far southwest and another well to the east were sampled. All these wells were found to be clean. Figure 1 shows water table depths at the different wells as measured during the investigation. Figure 2 is a contour of water table elevations calculated using measured depths corrected for topography and indicates a slight hydraulic gradient to the west-northwest. This is directly opposite to the natural gradient but is possible due to drawdown of the water table caused by pumping of nearby wells.
